INDOOR AIR QUALITY ASSESSMENT

**Massachusetts Department of Mental Health
Milot House
Tewksbury Hospital Campus
Tewksbury, Massachusetts**

Prepared by:
Massachusetts Department of Public Health
Bureau of Environmental Health
Emergency Response/Indoor Air Quality Program
July 2007

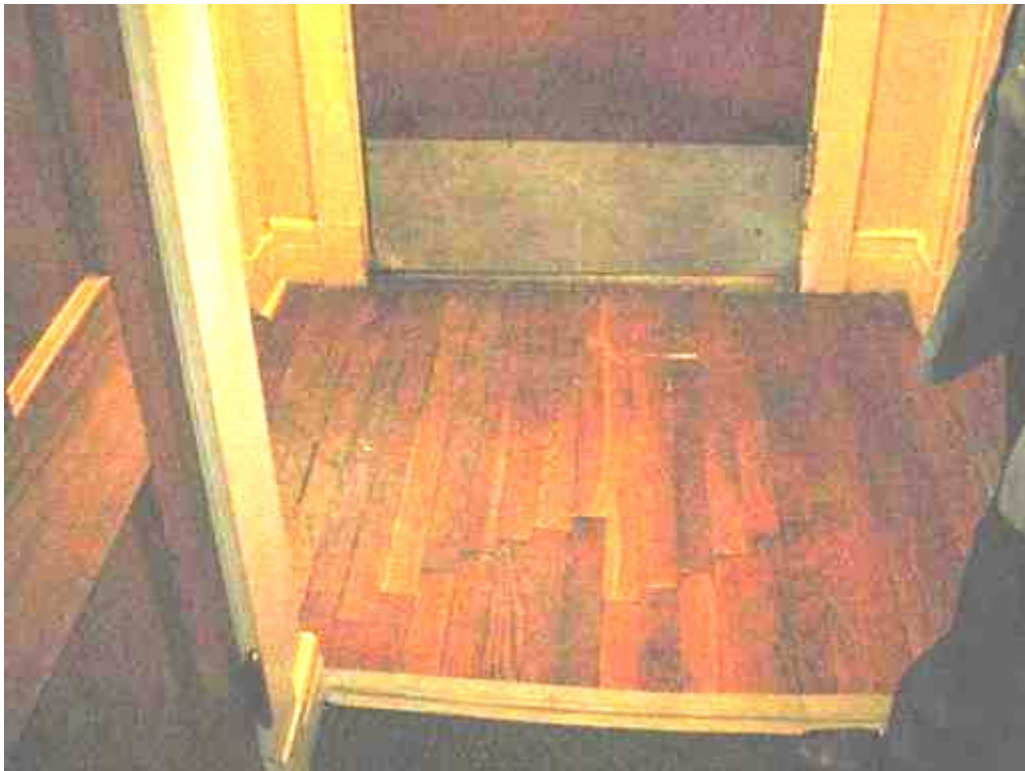
Picture 1

As mentioned previously, the request was prompted by mold concerns. Mr. Napolitano and Mr. Lamothe reported that prior to the MDPH assessment a water-damaged carpet had been removed from the vicinity of the rear entrance of the building. Removal of the carpet reportedly reduced the musty/mold-odors.

Area of odors near exterior rear door, where carpeting was removed

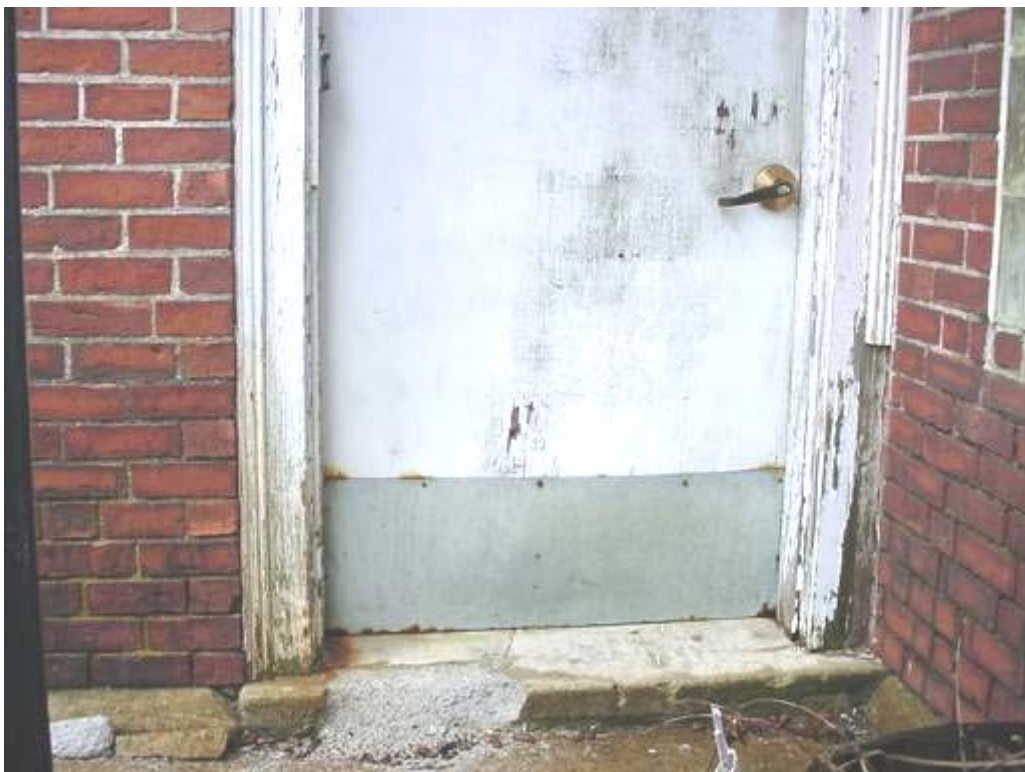
Picture 2

In order for building materials to support mold growth, a source of moisture is necessary. Should building materials become wet, identifying and eliminating water moistened building materials is necessary to control mold growth. Building materials with increased moisture content over normal concentrations may indicate the possible presence of mold growth. Identification of the location of materials with increased moisture levels can also provide clues concerning the source of water supporting mold growth. As previously mentioned, carpeting in the vicinity of the rear door was removed (Picture 1). BEH staff examined this door and found that the wood was severely water damaged and colonized with mold (on the exterior) at the time of the assessment (Picture 2).

Heavily damaged wooden exterior rear door, dark stains indicate mold growth

1. Replace damaged exterior rear door.
2. Have furnace inspected to ensure proper installation/operation. Make repairs as needed.

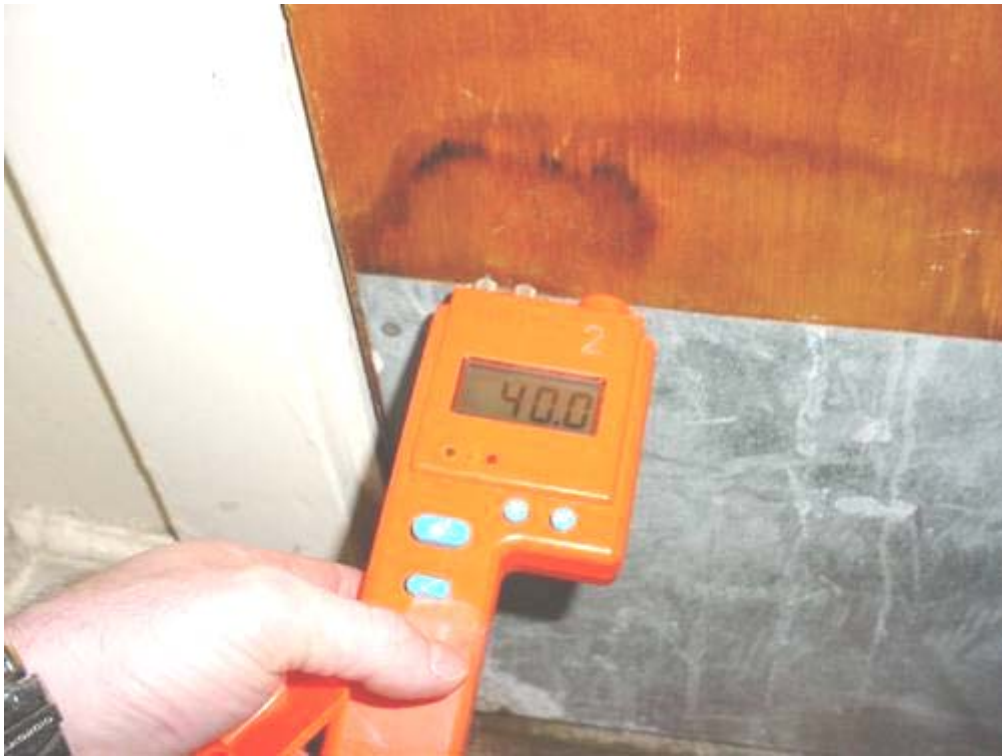
Picture 3

Elevated moisture measurement of exterior rear door

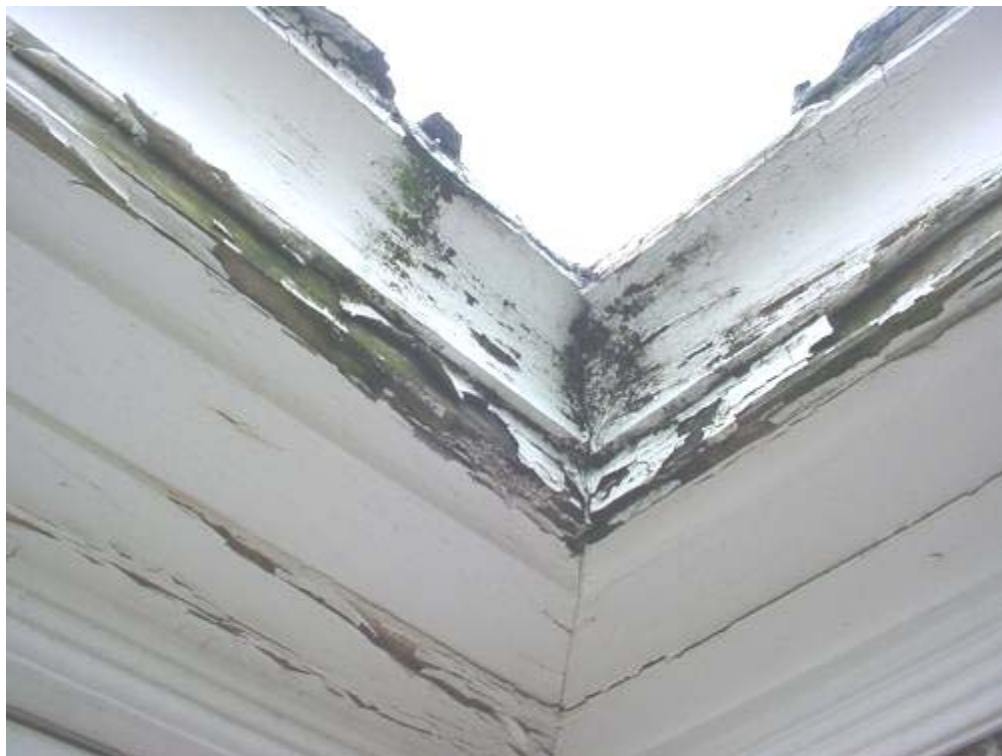
Picture 4

The source of moisture is likely rainwater accumulating against the building exterior, due to a lack of gutter/downspout system along the roof edge (Picture 4). Wooden eaves along the

As discussed, the wooden eaves of the building are damaged due a lack of a gutter/downspout system. As depicted in Picture 4, the cornice shows extreme signs of deterioration. Interior building materials in a corresponding second floor area also showed signs of water damage (Picture 8).

Damaged/rotted wooden cornice at rear of building directly above door in Pictures 1-3, note the lack of a gutter/downspout system

1. Consider consulting with an architect, masonry firm or general contractor regarding the integrity of the building envelope, primarily concerning water penetration through exterior walls. This measure should include a full building envelope evaluation.
2. Install gutters and downspouts to direct water away from the building.

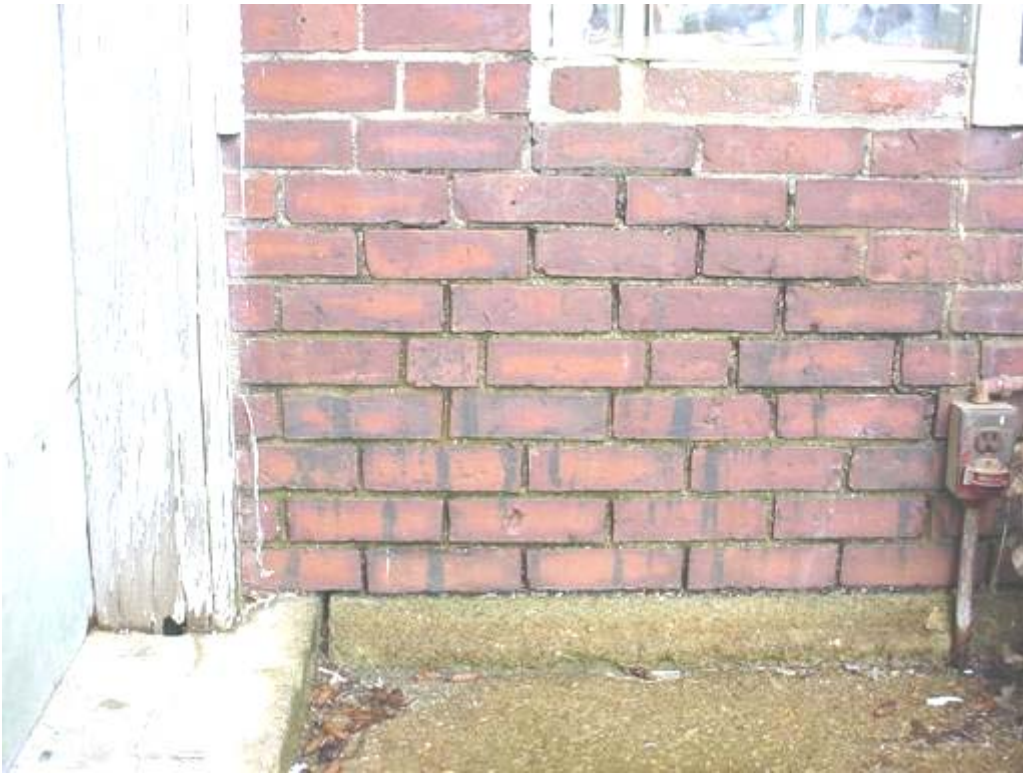
Picture 5

roof edge, especially at the cornice, showed signs of damage and swelling. Water splashing along the edge of the building moistens the base of exterior walls, creating a characteristic staining. Growth of moss on exterior brickwork is also an indication of chronic moisture exposure from rainwater (Picture 5). Moss growth holds moisture against brickwork, which can further damage the building exterior. North-facing corners and walls of this building are particularly vulnerable to prolonged moisture exposure, since the brick is not dried out by exposure to direct sunlight. During winter weather, the freezing and thawing of moisture in bricks can accelerate the deterioration of brickwork. Over time, chronic moisture exposure has resulted in damage to the building's exterior (Pictures 6 and 7).

Moss growth due to chronic water exposure near rear exterior door

7. Clean exterior walls of moss and debris.
8. Refer to "Mold Remediation in Schools and Commercial Buildings" published by the US Environmental Protection Agency (US EPA, 2001) for information concerning mold and mold remediation. Copies of this document can be downloaded from the US EPA website at: http://www.epa.gov/iaq/molds/mold_remediation.html.

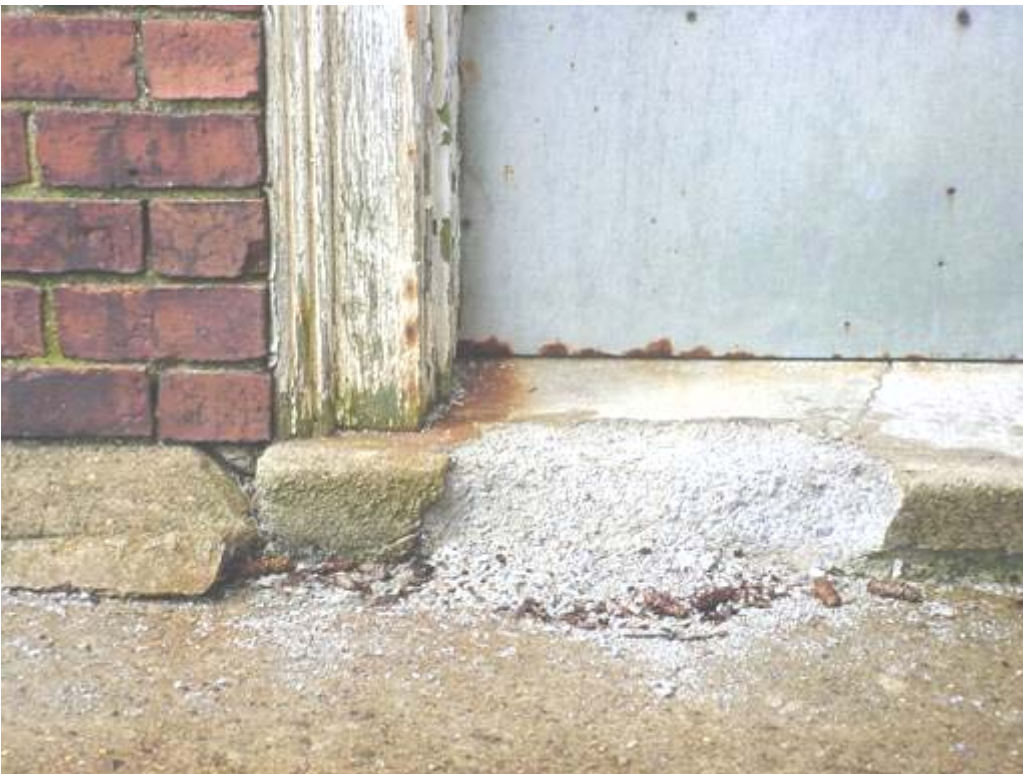
Picture 6

Damage to wood molding and cement due to chronic water exposure near rear exterior door

3. Repair/replace damaged exterior wooden doors and moldings.
4. Repair/replace damaged interior of materials in side entrance stairwell.
5. Repair/replace loose/broken windowpanes and missing or damaged window caulking building-wide to prevent water penetration through window frames.

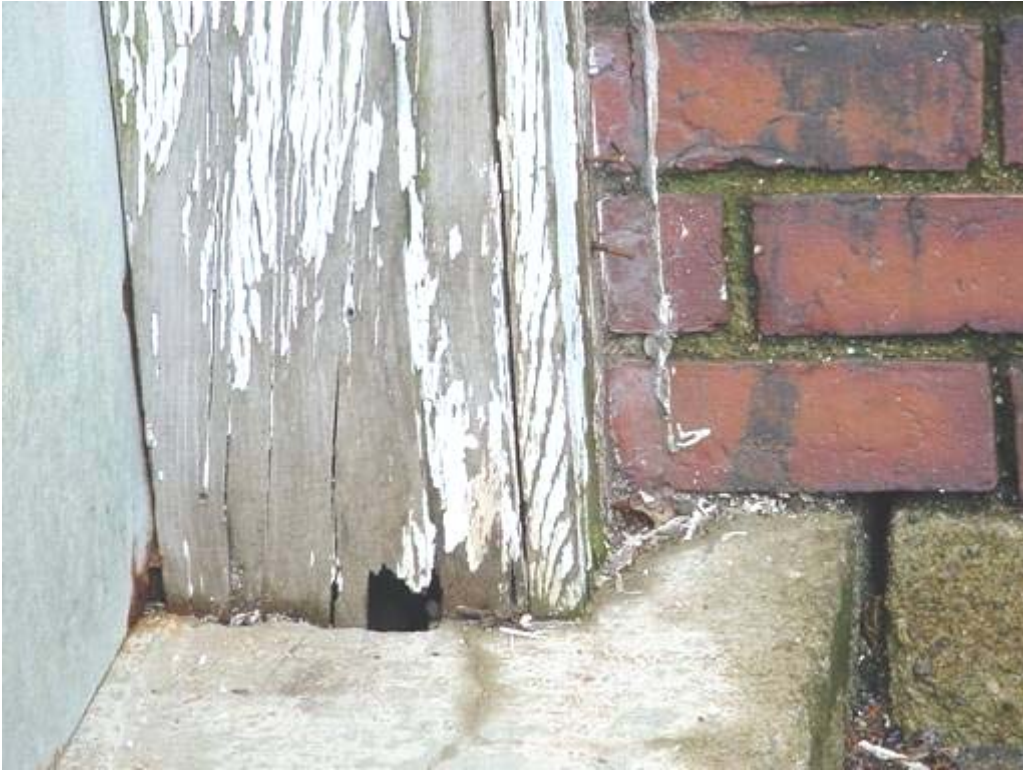
Picture 7

Damage to wood molding due to chronic water exposure near rear exterior door

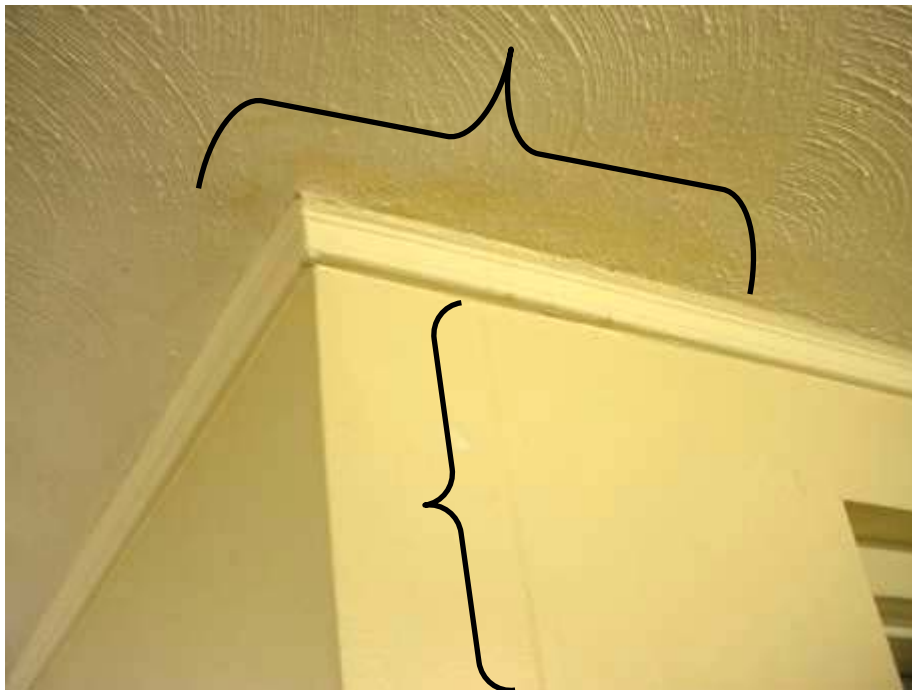
Picture 8

**Water damaged ceiling plaster and drip mark down wall indicating water penetration
(Note: This interior area corresponds directly to the damaged cornice in Picture 4)**

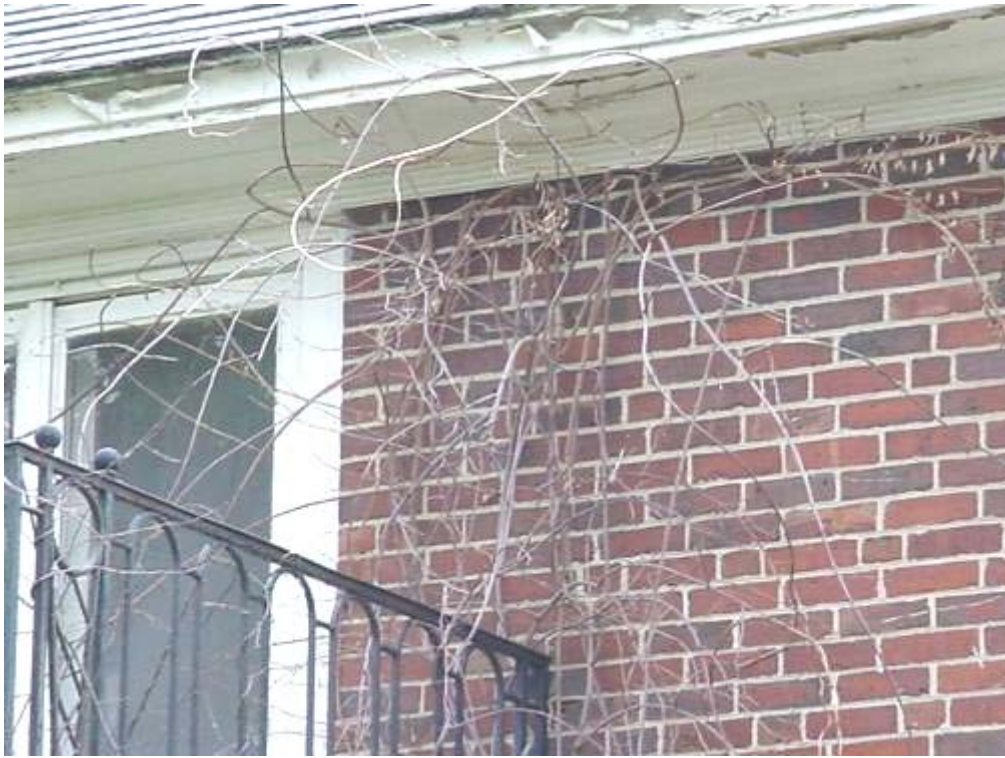
Picture 9

- Clinging plants on exterior walls (Pictures 9 and 10). Clinging plants can cause water damage to brickwork through insertion of tendrils into brick and mortar. Water can penetrate into the brick along the tendrils. Water trapped in brick can subsequently freeze and thaw during the winter. This freezing/thawing action can weaken bricks and mortar, resulting in wall damage.
- Missing/damaged mortar and cracks in exterior brick/stone (Pictures 11 through 13).
- Rotted wood and spaces around flashing and in masonry around windows (Pictures 14 through 16).
- An abandoned dryer exhaust vent (Picture 17).

Clinging plants on exterior wall

5. Unclog drain near basement doors. Inspect periodically for proper drainage.
6. Remove plant growths against the exterior wall/foundation of the building to prevent water penetration.

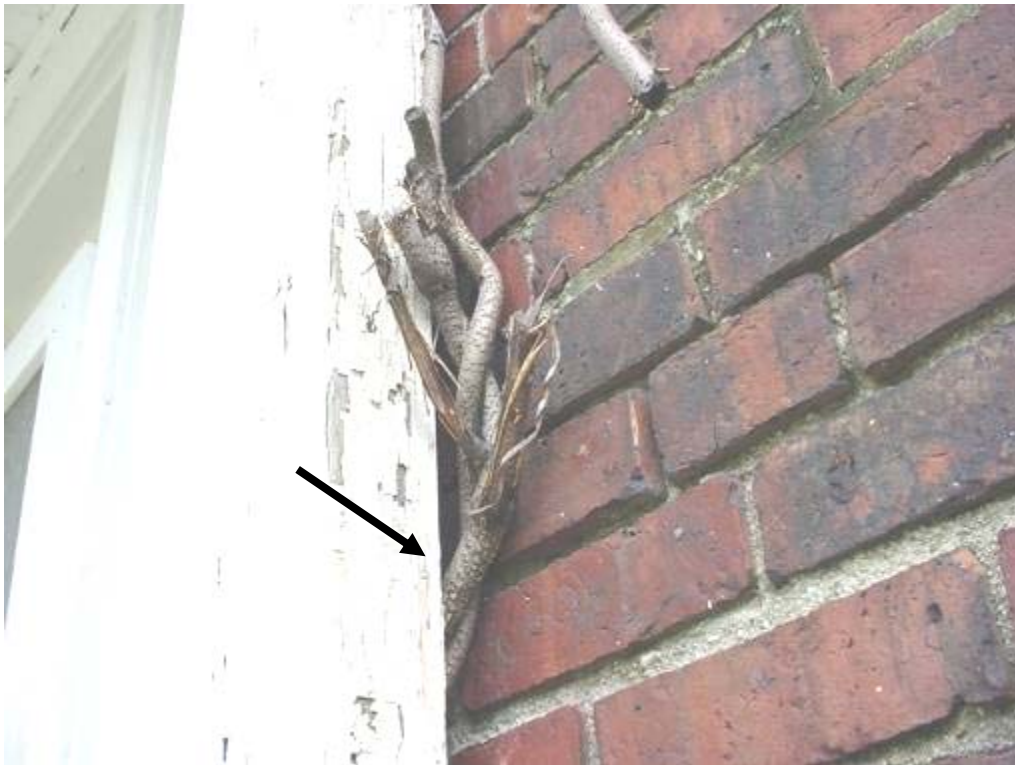
Picture 10

**Close-up of Clinging plants on exterior wall,
Note trunk has worked its way between wooden trim and brick**

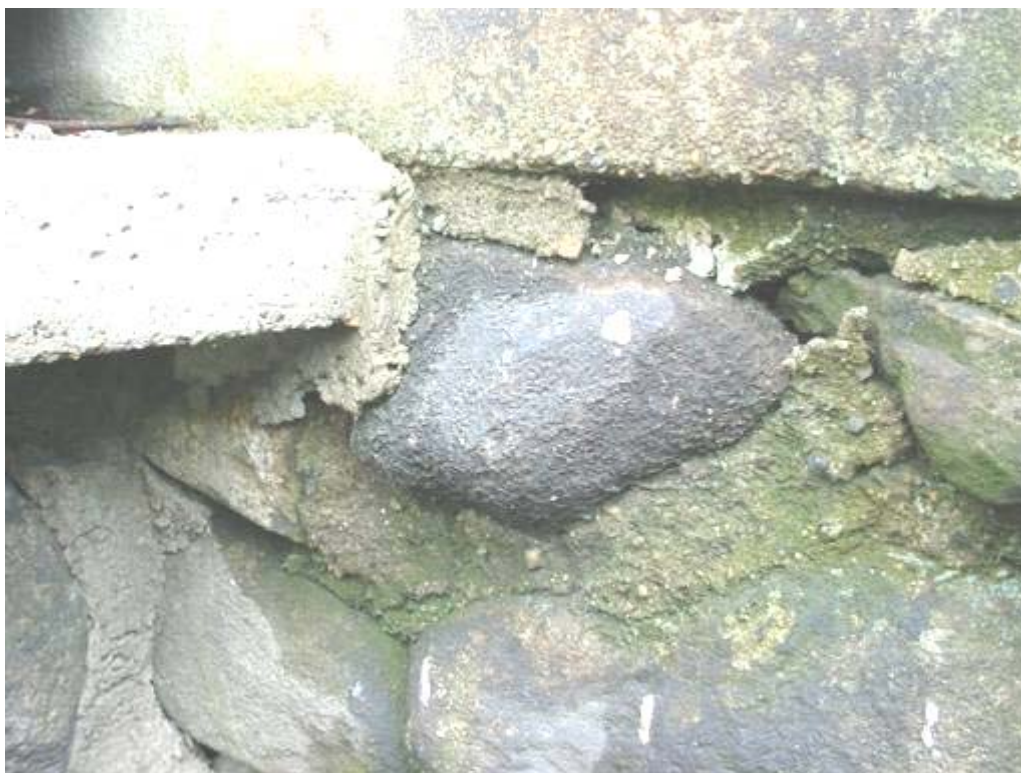
Picture 11

Missing/damaged mortar around foundation stone

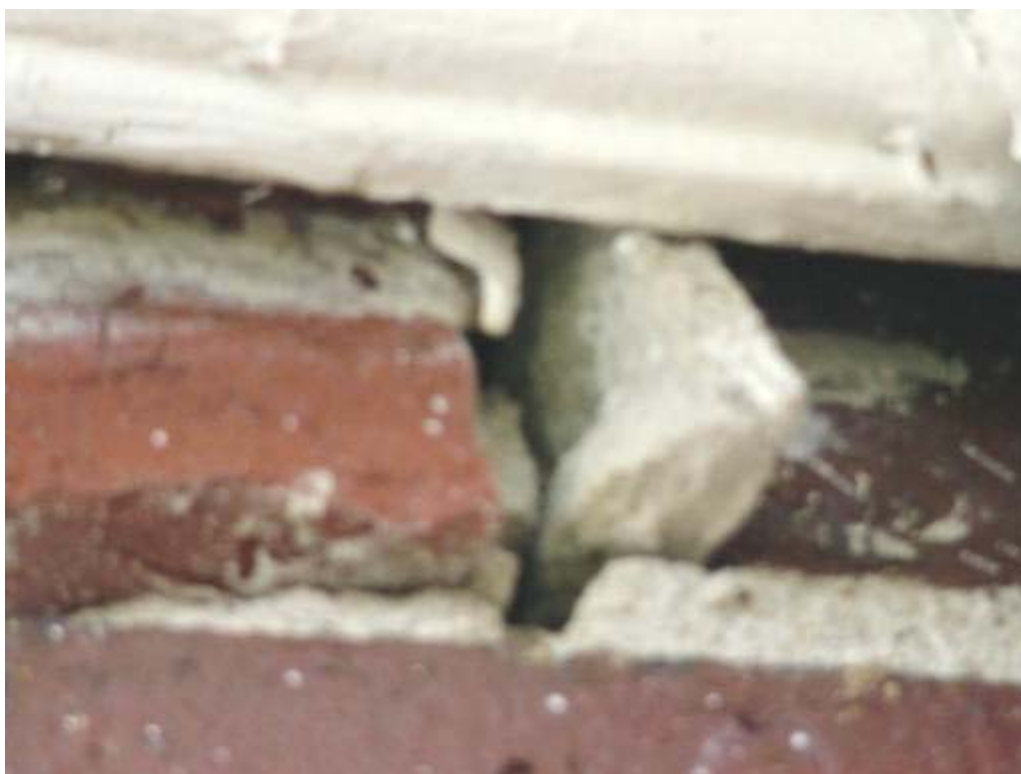
Picture 12

Missing/damaged mortar around exterior brick

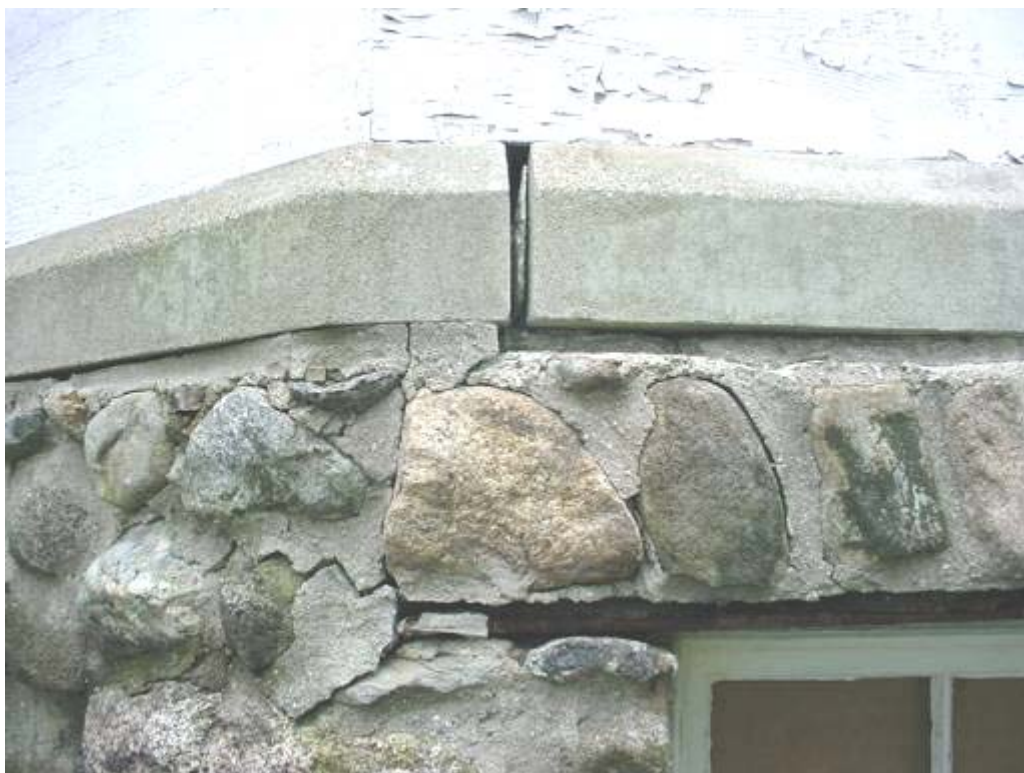
Picture 13

Missing/damaged mortar around foundation stone

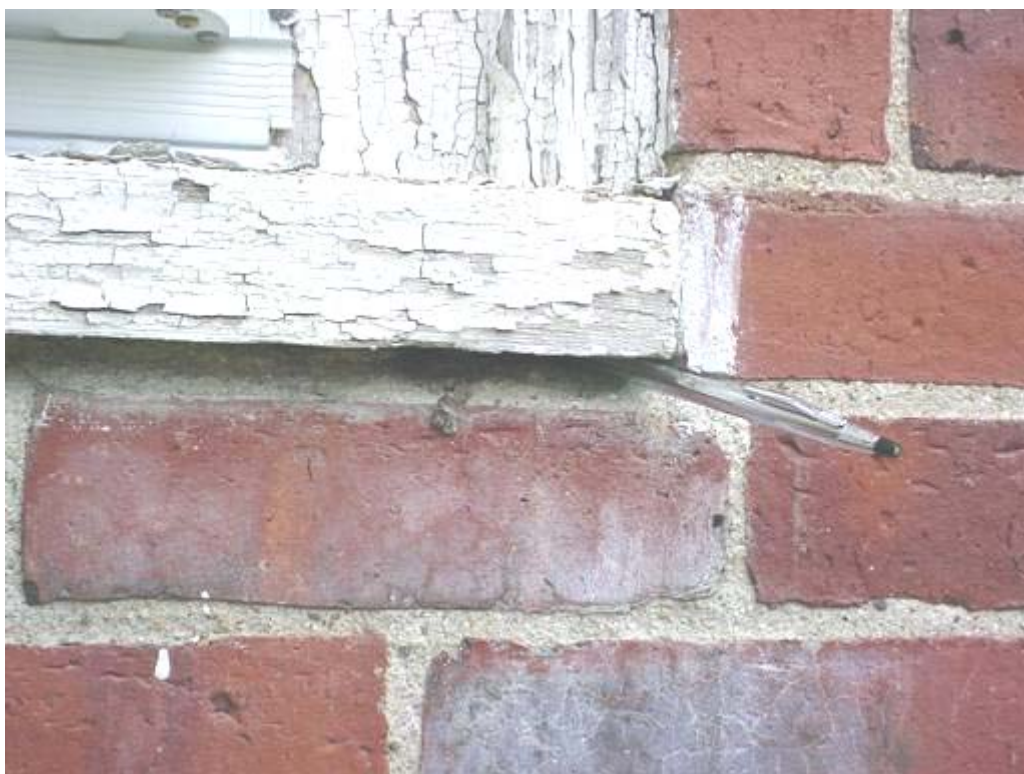
Picture 14

Spaces around exterior windows, probe inserted by BEH staff to illustrate depth

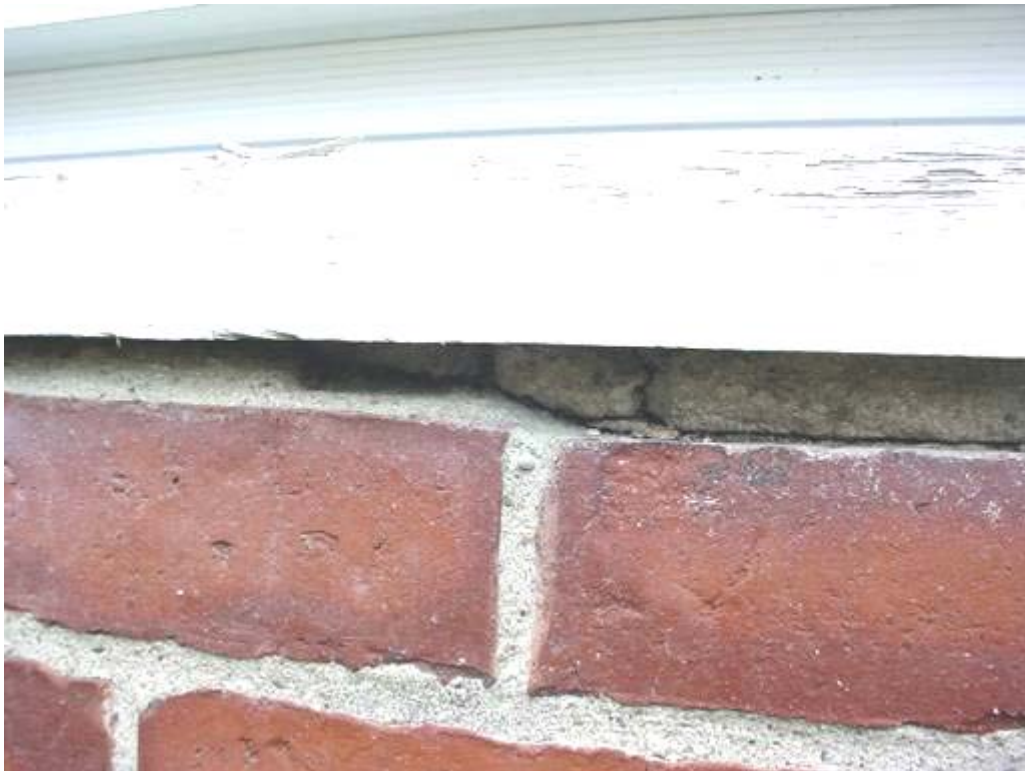
Picture 15

Close-up of spaces around exterior windows

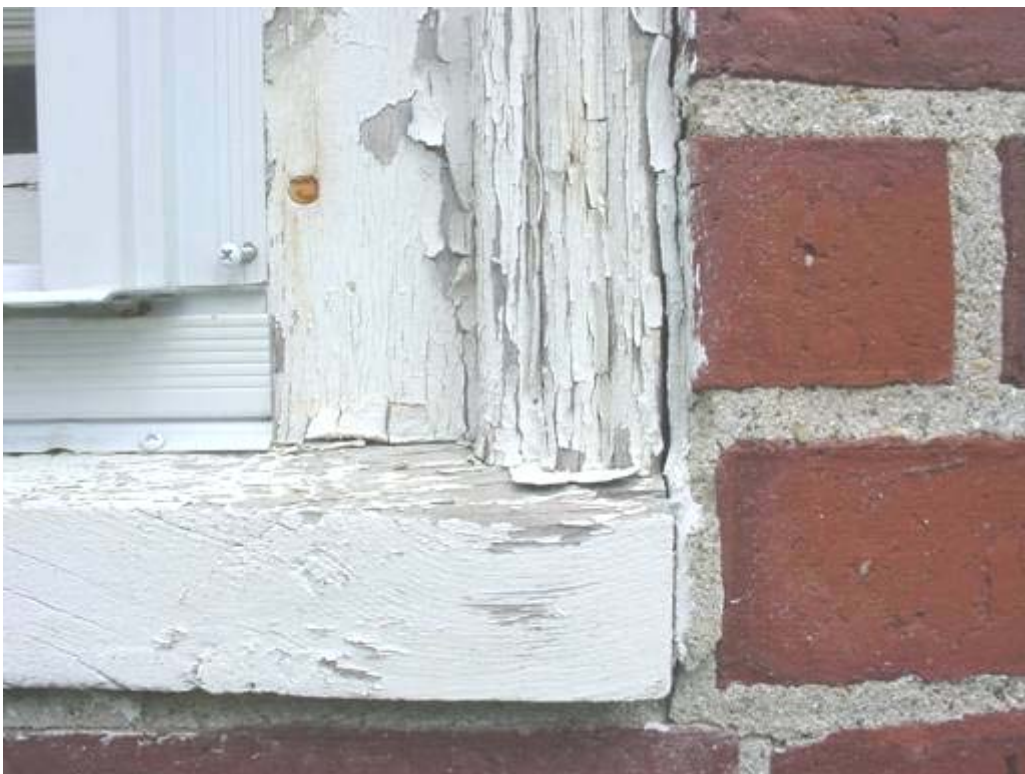
Picture 16

Rotted/damaged wooden windowsills

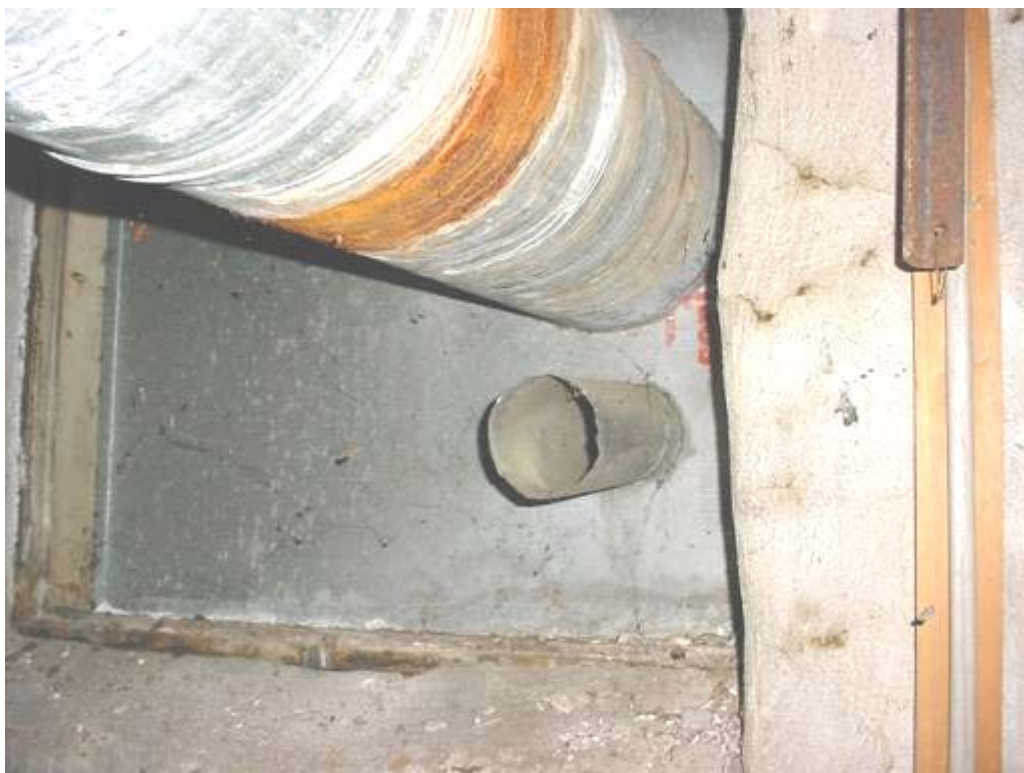
Picture 17

Abandoned dryer exhaust vent

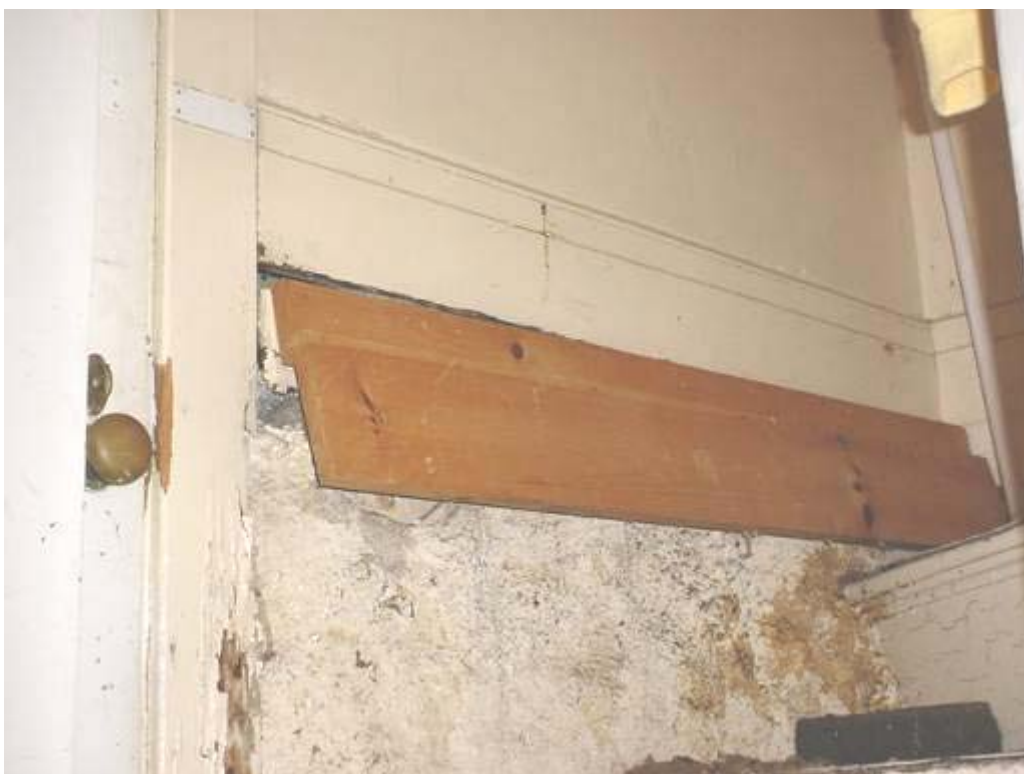
Picture 18

- Damage to an exterior door/wall resulting in severe water damage to the side entrance stairwell (Pictures 18 and 19). Note, this entrance is sealed and the stairwell is not used by DMH staff.
- Clogged exterior drain and damaged wooden door to basement (Pictures 20 and 21).

Wall breach in side stairwell partially sealed with wood

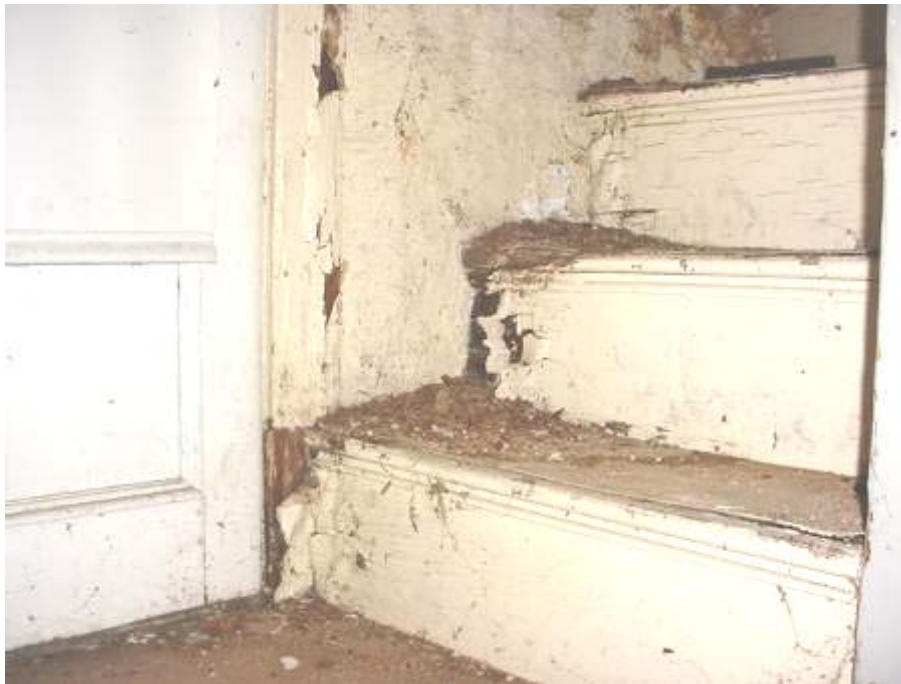
Picture 19

**Severe damage to wall plaster and wooden stairs due to water penetration in side stairwell,
Note piles of debris are corroded wood**

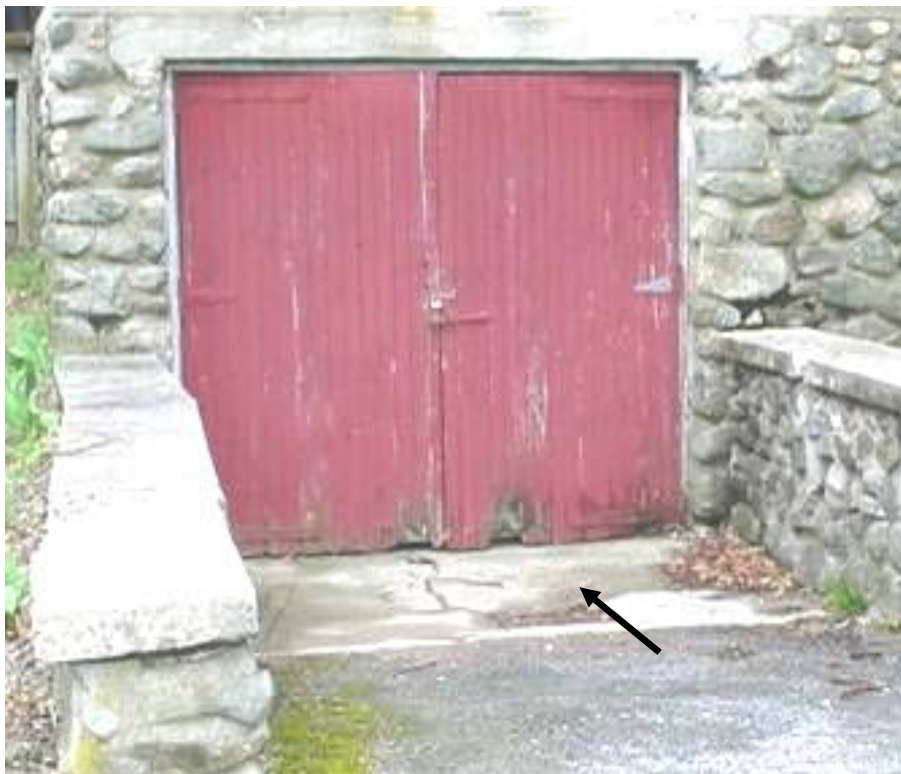
Picture 20

Damaged base of basement door, Note drain in foreground

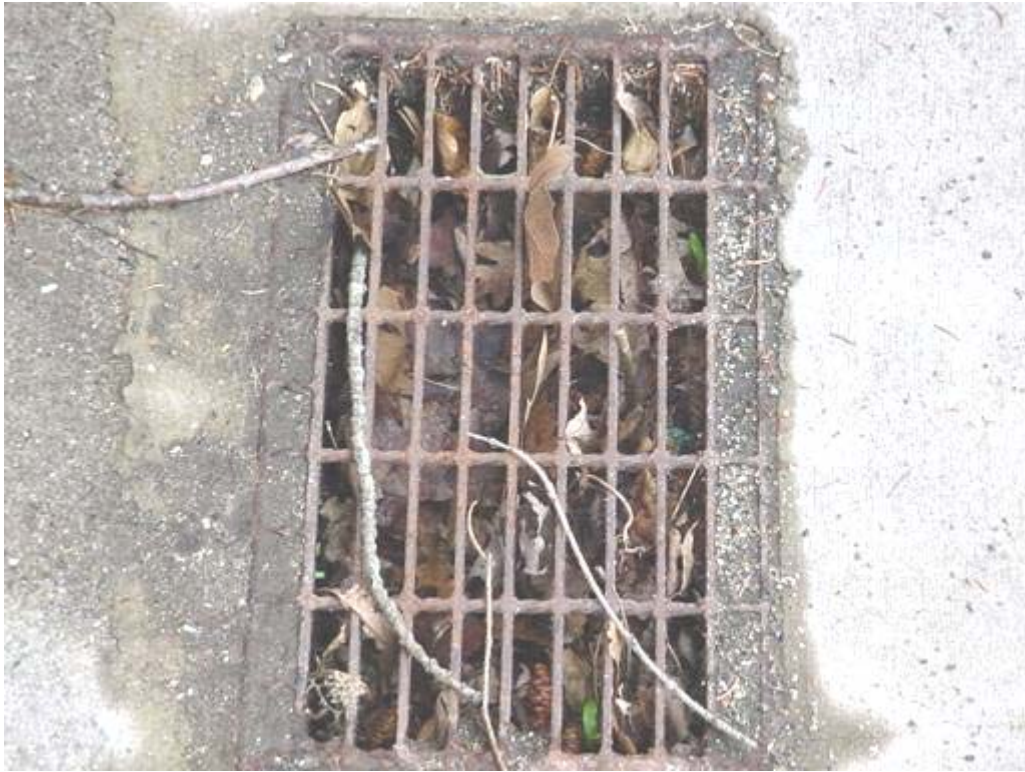
Picture 21

Close-up of clogged drain near basement doors

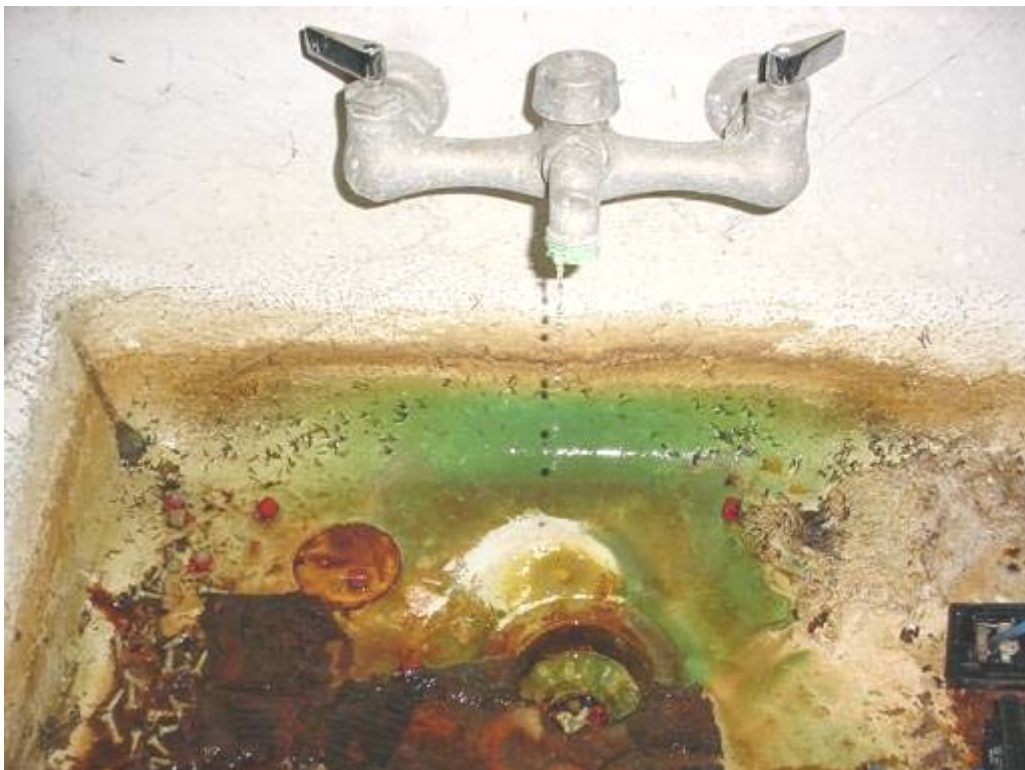
Picture 22

It is also worth noting that a leaking sink and cardboard boxes stored directly on the cement floor were observed in the basement. Moistened porous materials can provide a source for mold growth (Pictures 22 and 23).

Leaking sink in basement

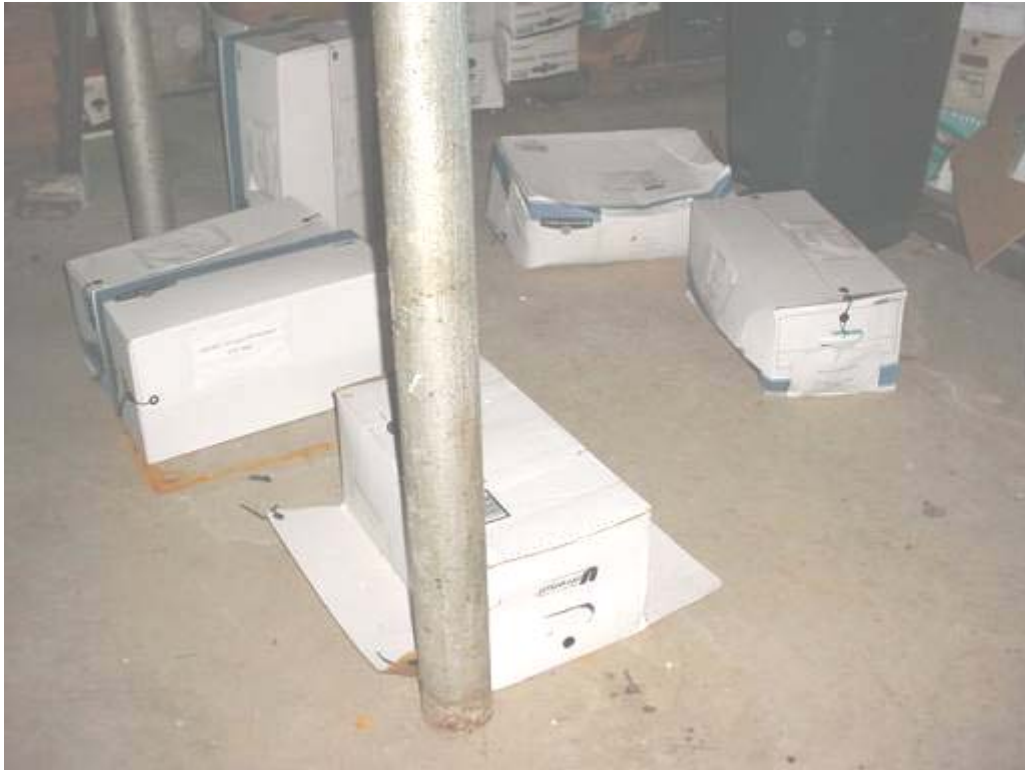
Picture 23

Cardboard boxes on cement floor of basement

4. Refrain from storing porous materials directly on basement floor. Inspect and discard any water damaged/mold colonized materials. Disinfect any areas of microbial growth with a mild detergent or antimicrobial, wipe clean surfaces with soap and water after disinfection.

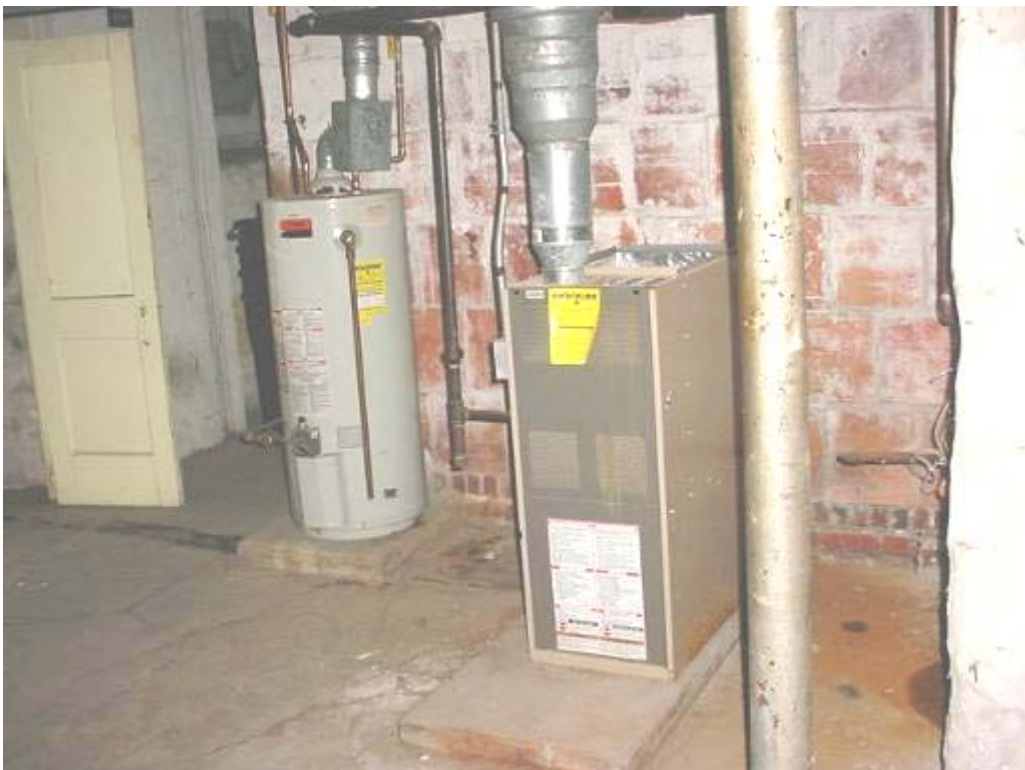
Picture 24

While in the basement, Mr. Holmes and Mr. Lamothe observed a furnace operating (Picture 24). Upon closer inspection, it appeared that the furnace was missing its cover and venting *into* the basement (Picture 25). Not only can the furnace serve as a point source of combustion products into the basement (e.g., carbon monoxide), but it can also pressurize the basement, forcing odors and particulates into occupied areas of the building.

Furnace in basement, missing its cover

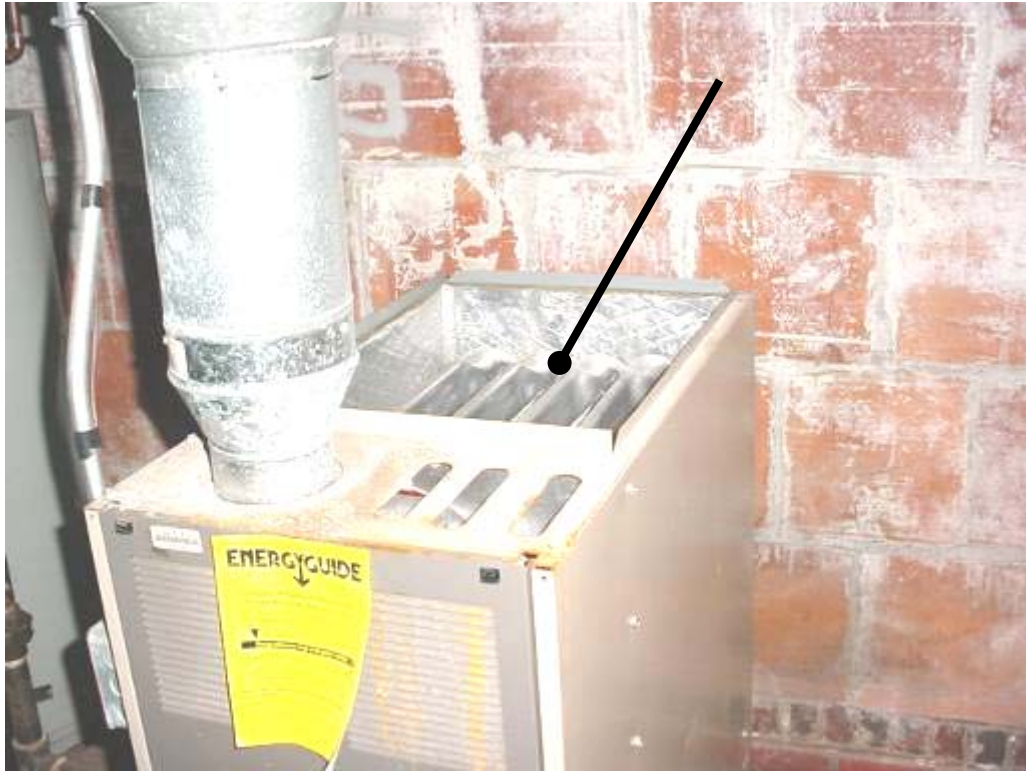
Picture 25

Furnace in basement, missing its cover
